# TEST REPORT

Sample Underground Battery Box

Type UBB12200 (1×12V 200Ah)

**Test Item:** IP67

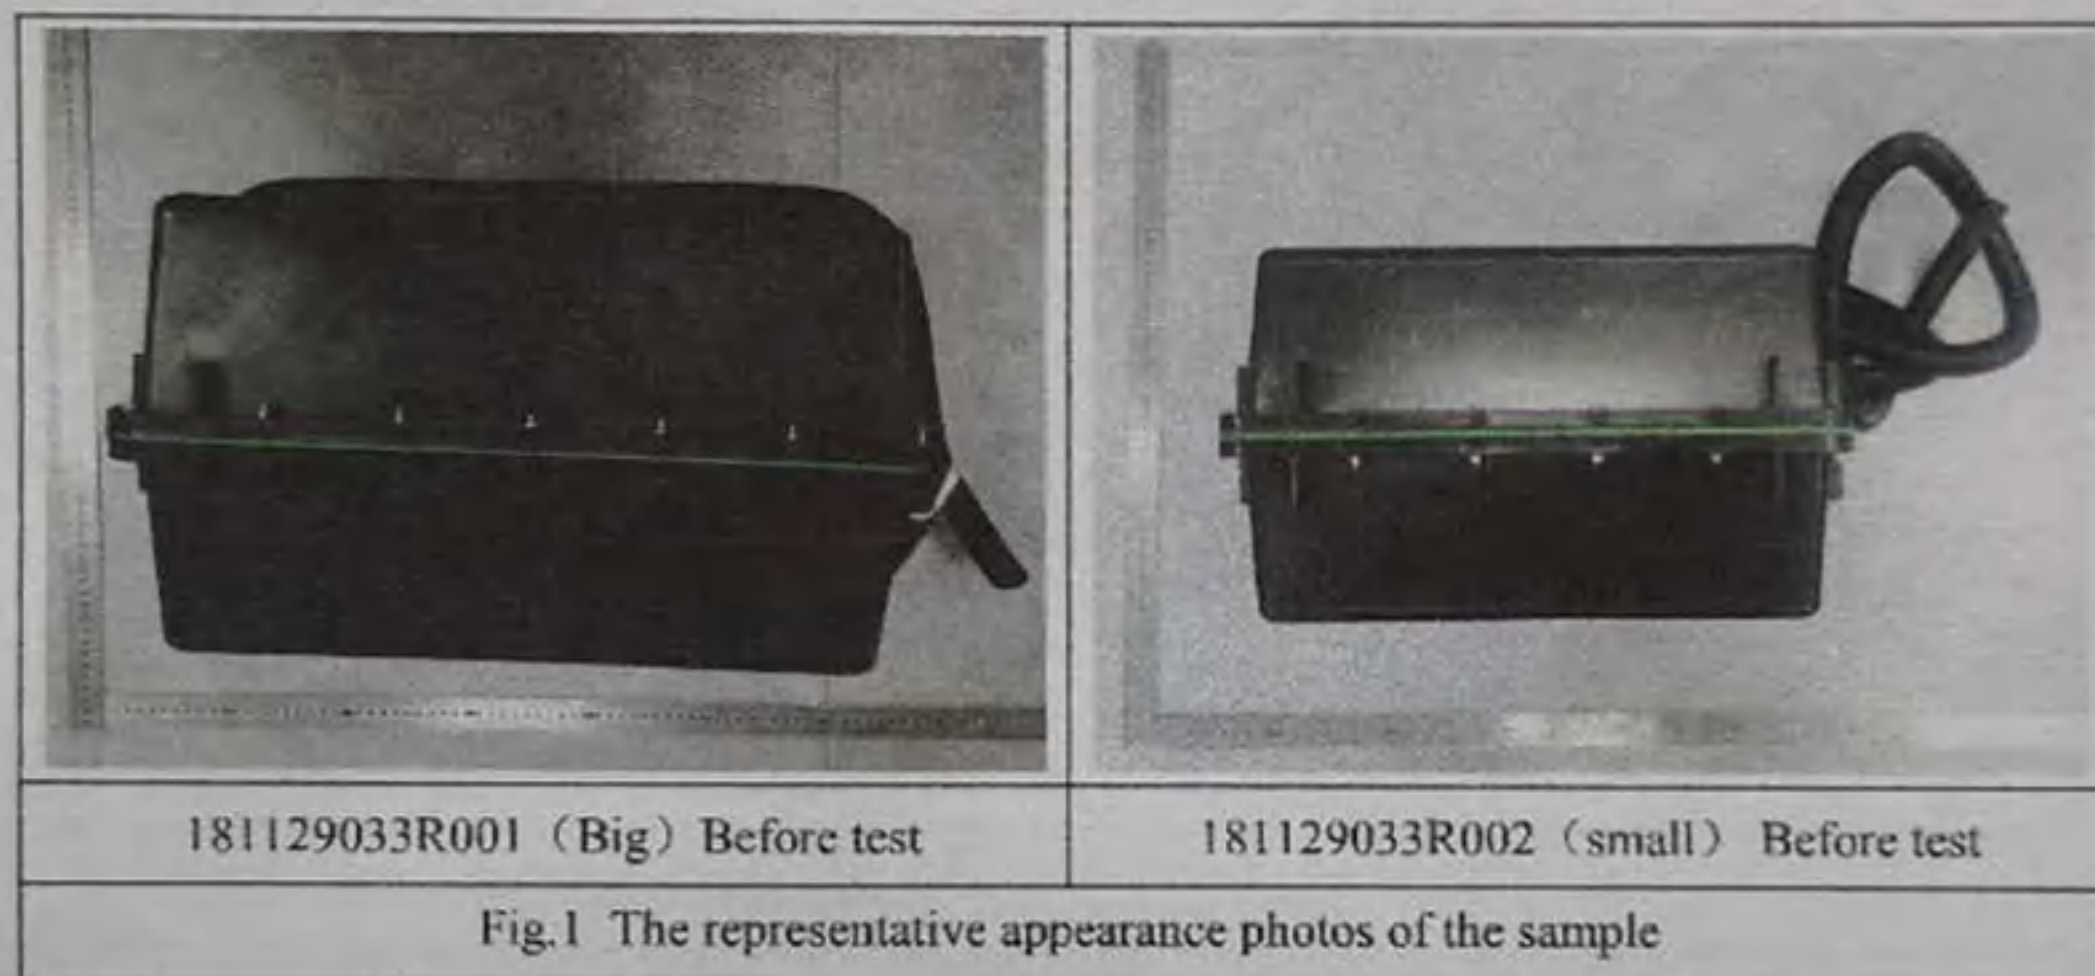
2pcs samples were submitted by the client for IP67 test. The sample description was shown in Table 1. The representative appearance photos of the samples before test were shown in Fig.1.

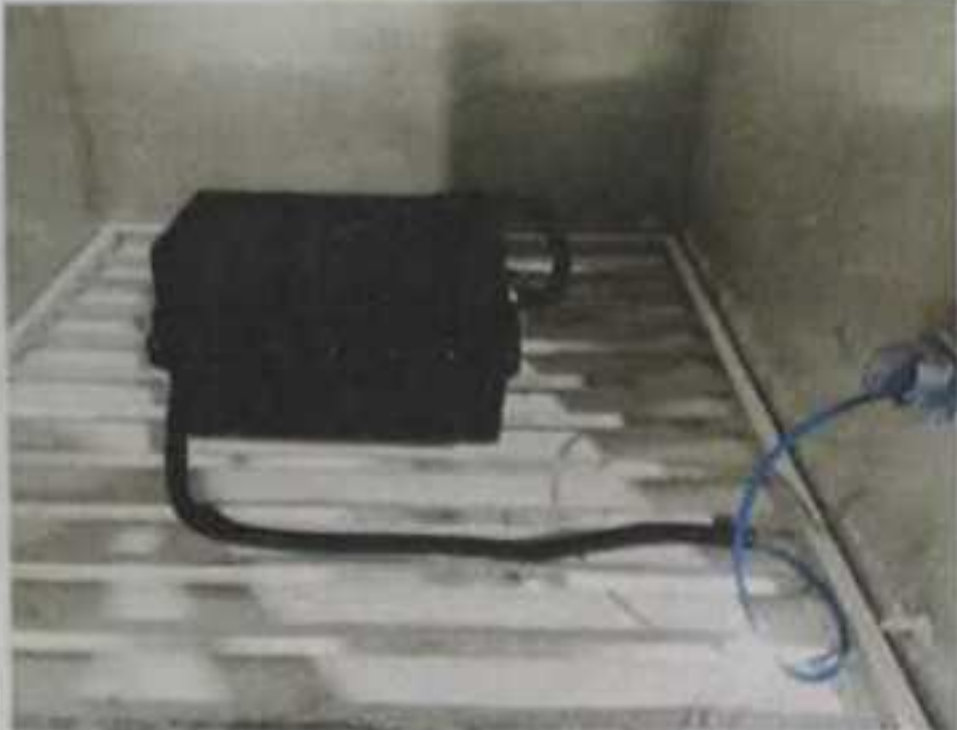
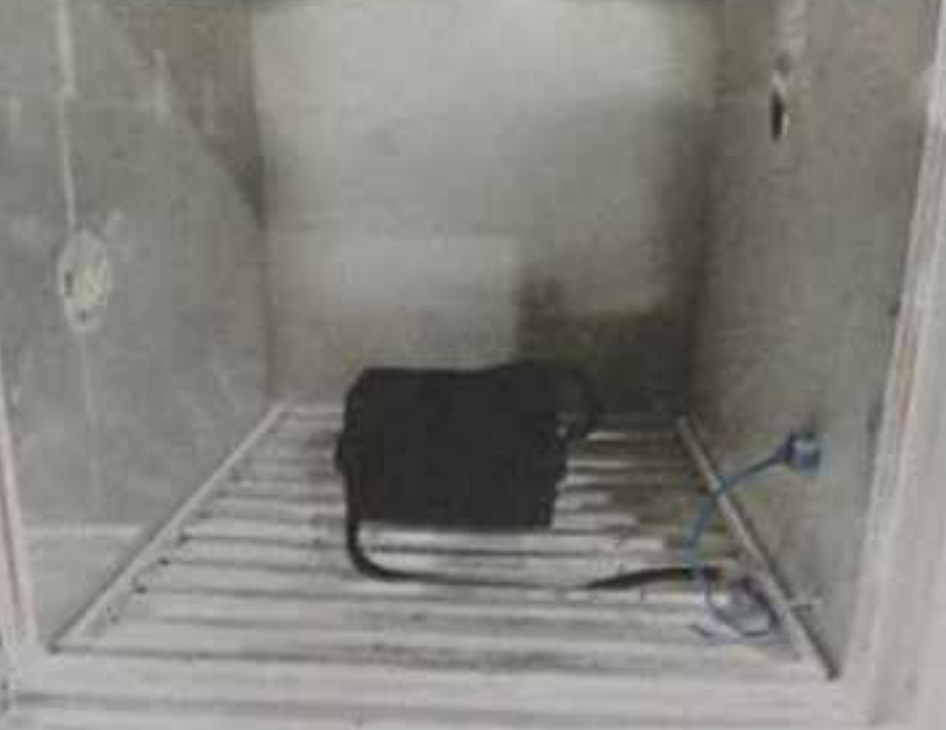
Test Item	Test conditions
IP6X	Talc powder dust: 2Kg / m <sup>3</sup> Duration: 8h
IPX7	The water surface is at least 0.15m above the top of the sample casing, The bottom of the case is at least 1m below the surface of the water, Test duration: 30min

<p>IP6X Dust-proof test process Photo</p>	<p>IP6X Dust-proof test process Photo</p>

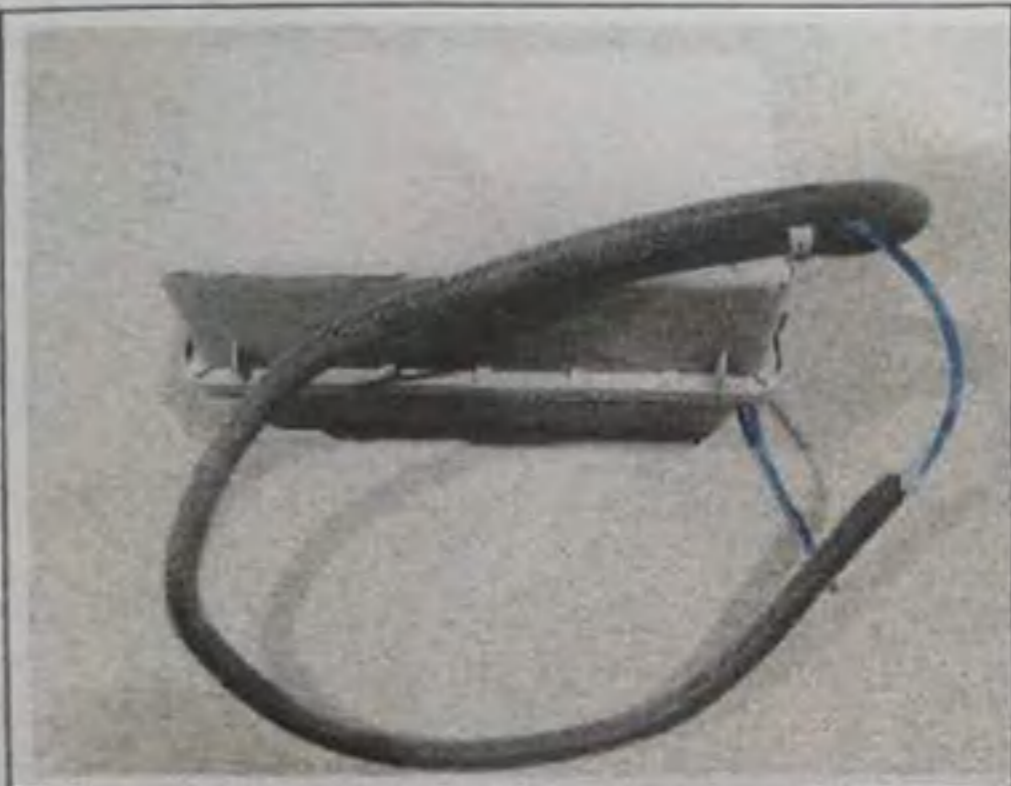
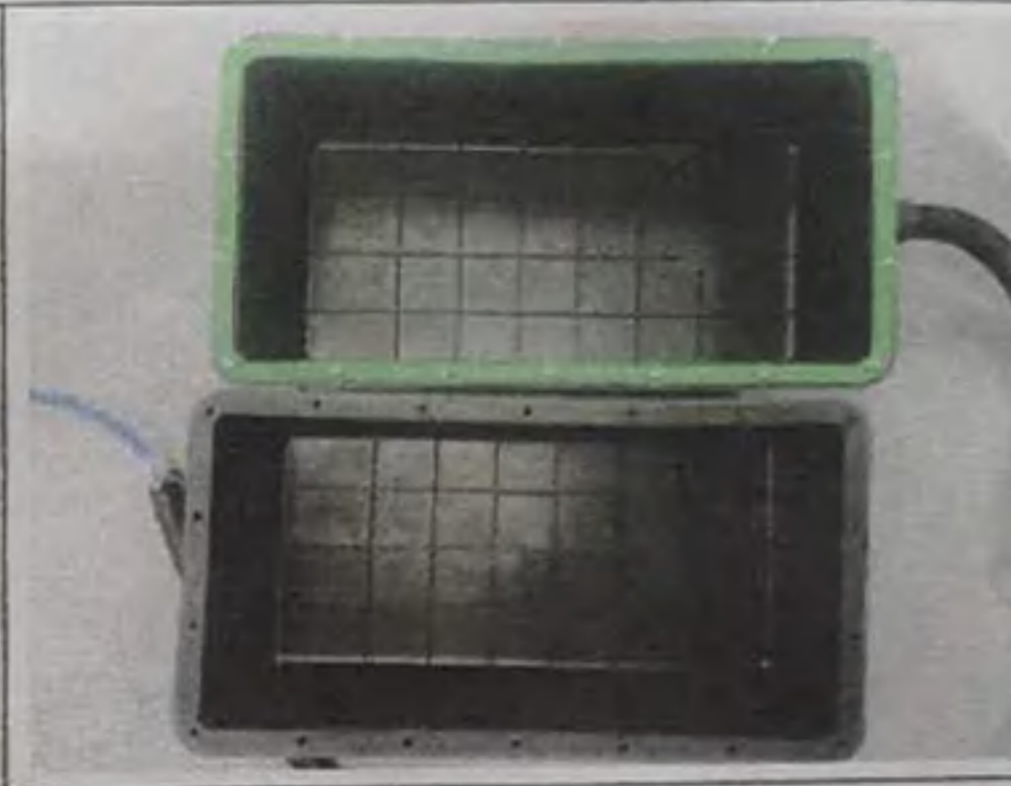
Sample name	Sample No.	Test item	Test result
Underground Battery Box	181129033R001	IP6X dust-proof test	There was no dust inside the sample after the test.
	181129033R002	IPX7 waterproof test	After the test, the inside of the sample entered without water.

<p>The photo after IP6X dust-proof test</p>	<p>The inside photo after IP6X dust-proof test</p>

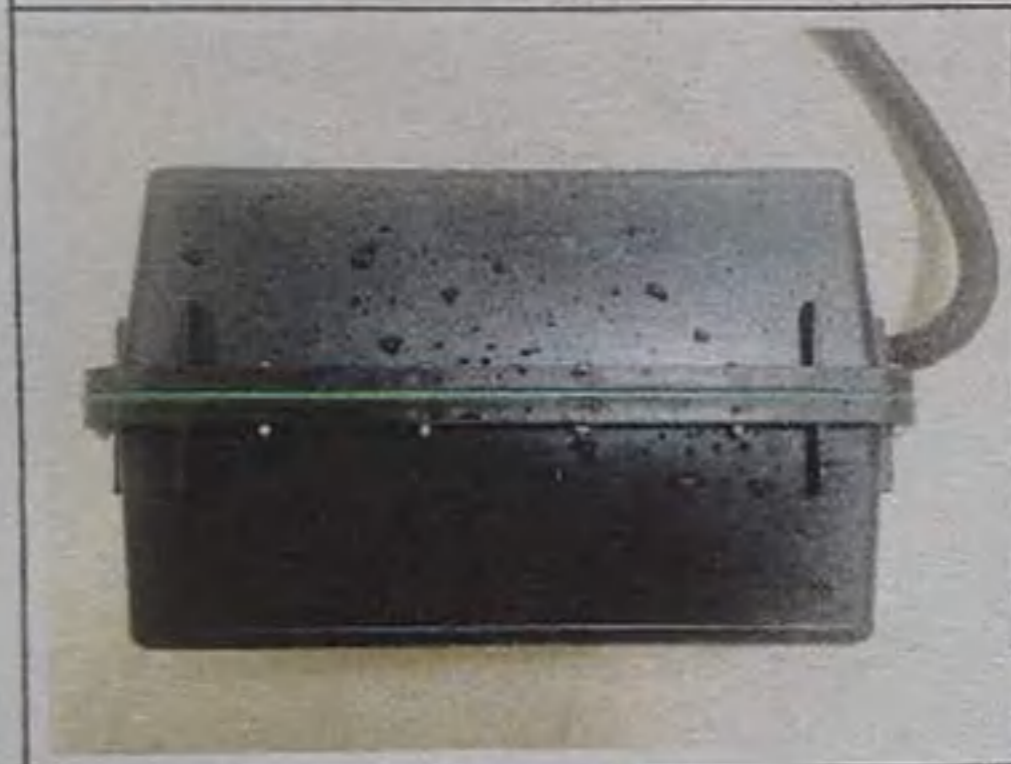
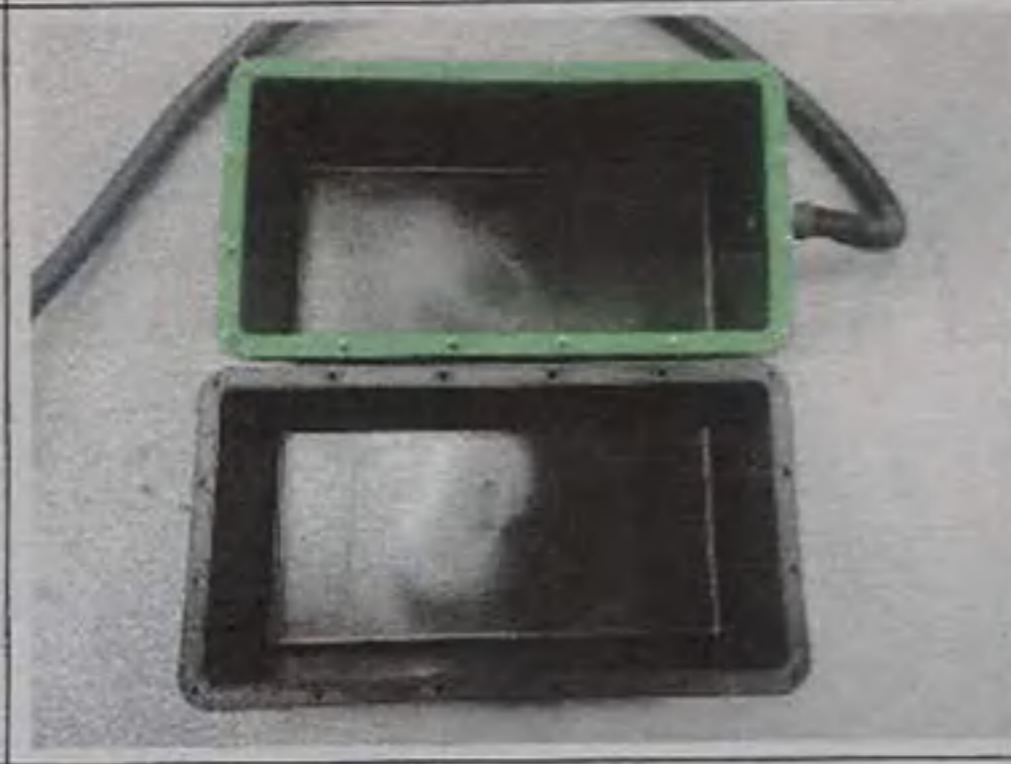
<p>The photo after IPX7 dust-proof test</p>	<p>The inside photo after IPX7 waterproof test</p>
<p>Fig.3 The photos after test</p>
